Investigation into Damaged Gear of Off-Road Motorcycles

Dagmar Bublíková, Hana Jirková, Kateřina Rubešová, Zbyněk Bunda

University of West Bohemia, RTI-Regional Technological Institute, Univerzitní 22, CZ – 306 14 Pilsen, Czech Republic, e-mail: dagmar.bublikova@seznam.cz

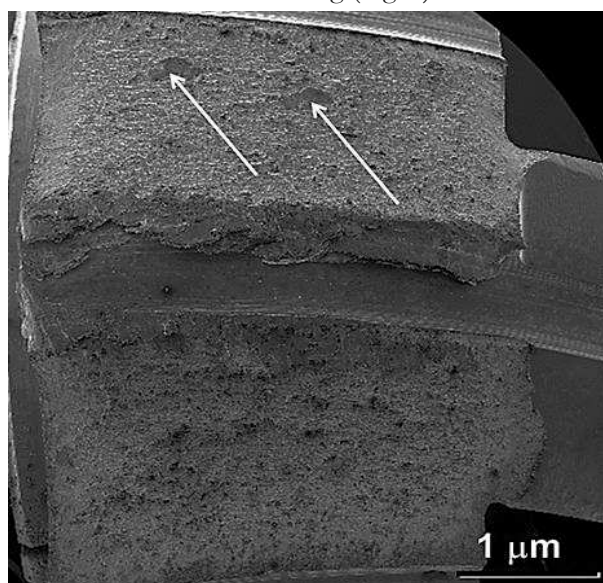
Fracture surfaces in the damaged gear wheel were examined using electron microscopy. The fracture was of mixed nature: ductile fracture with dimples and a certain proportion of brittle phase (Fig. 3, Fig. 4). The fracture surfaces contained visible cracks caused by overloading (Fig. 5). In addition, there were spots in which chromium content was higher than elsewhere. Their average size was several dozen micrometres (Fig. 6). This was confirmed by point analysis using EDX (Fig. 7). These might have caused or contributed to the failure.

Fig. 3 General view of fracture surface with brittle fracture regions

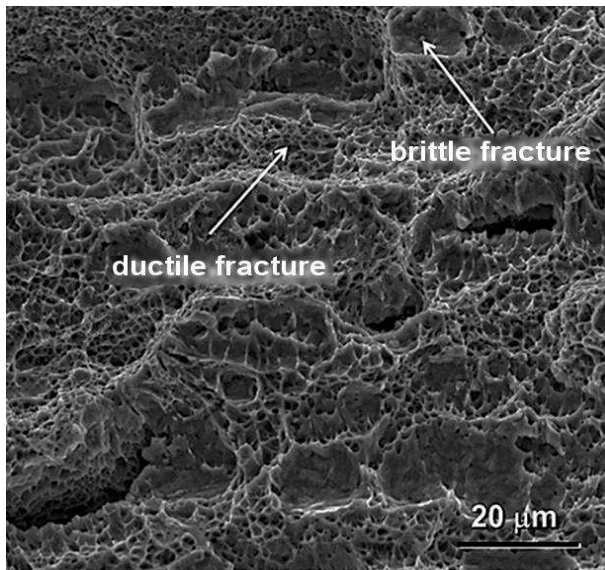
Fig. 4 Mixed fracture surface with steps

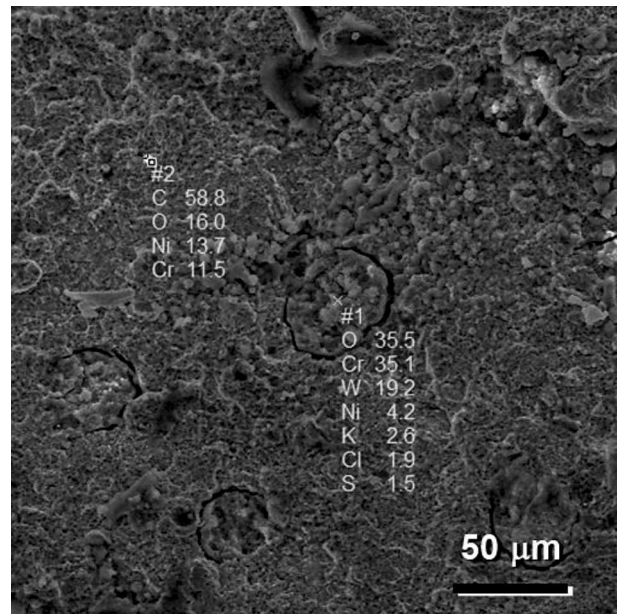
Fig. 7 Spots with increased chromium content – EDX analysis

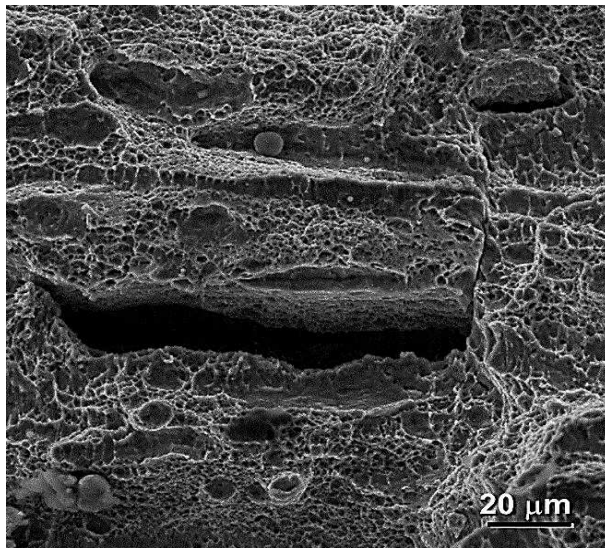
Fig. 5 Detail of surface created by in-service failure due to overloading

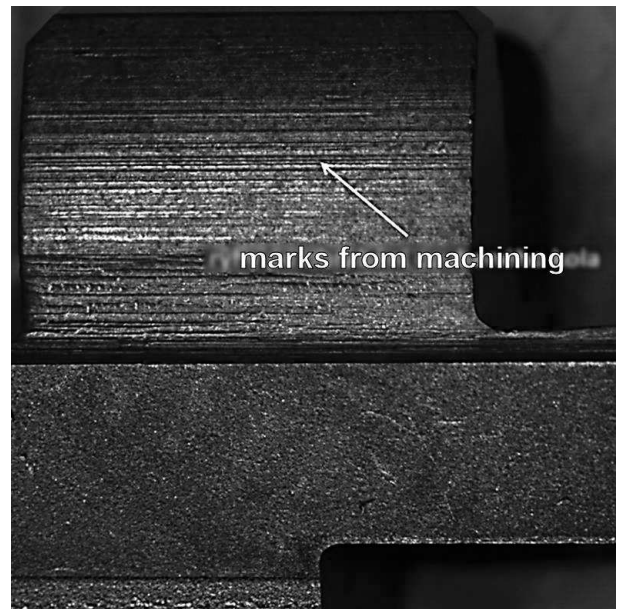
To assess the quality of surface of one of the gear wheels, a macrophotograph of its tooth was taken using a low-power stereomicroscope. The surface shows marks from machining (Fig. 8).

Fig. 8 Tooth face surface

Another factor which might have contributed to failure was the poor quality of the gear wheel surface in the most-severely stressed region at the bottom of teeth. The surface of teeth contain scratches which act as stress concentrators under load.

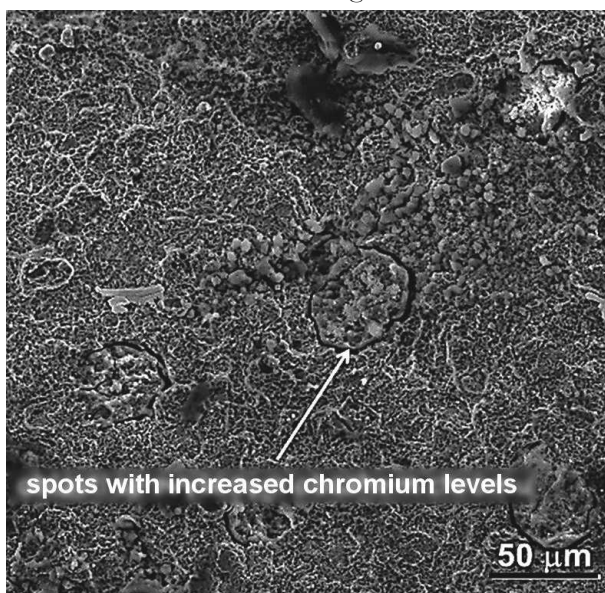
Fig. 6 Spots with increased chromium content

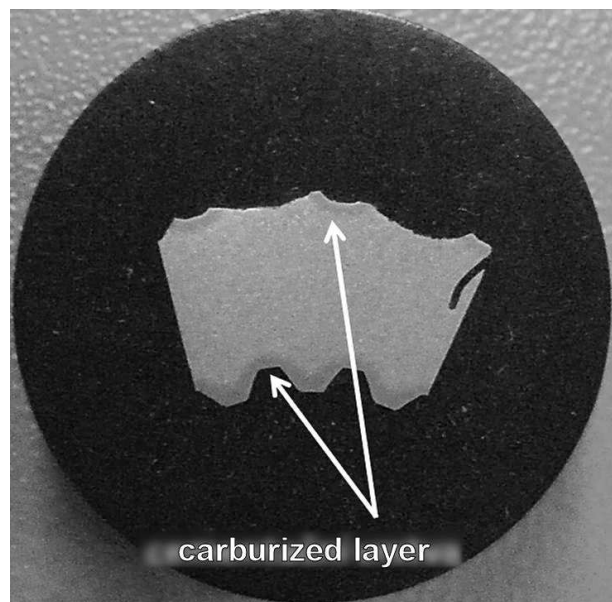
For the purpose of comprehensive characterization of the material, metallographic analysis was performed. The macrophotograph of a metallographic section shows the carburized layer on the surface (Fig. 9). A scanning electron micrograph of metallographic section through an intact gear wheel tooth (Fig. 10) shows long cracks which spread from the bottom of the tooth across the carburized layer all the way into the base material (Fig. 11). Smaller cracks and carbide network along prior austenite grain boundaries were found in the top of the tooth and in its core (Fig. 12).

Fig. 9 Metallographic section showing the carburized layer

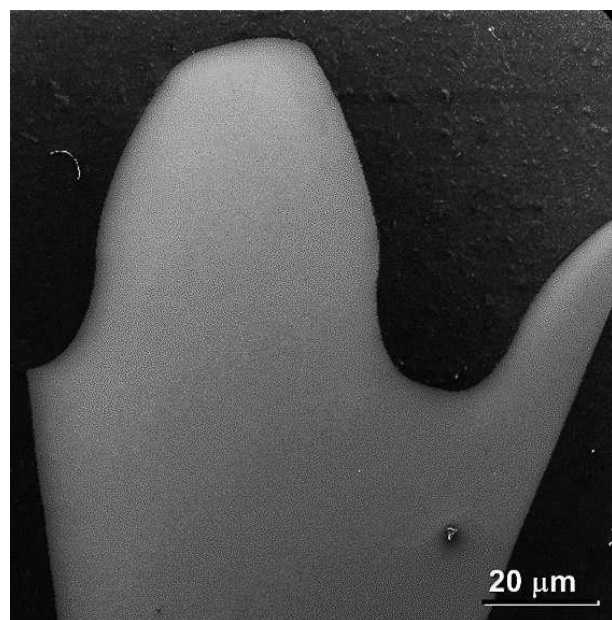
Fig. 10 Metallographic section through an intact tooth

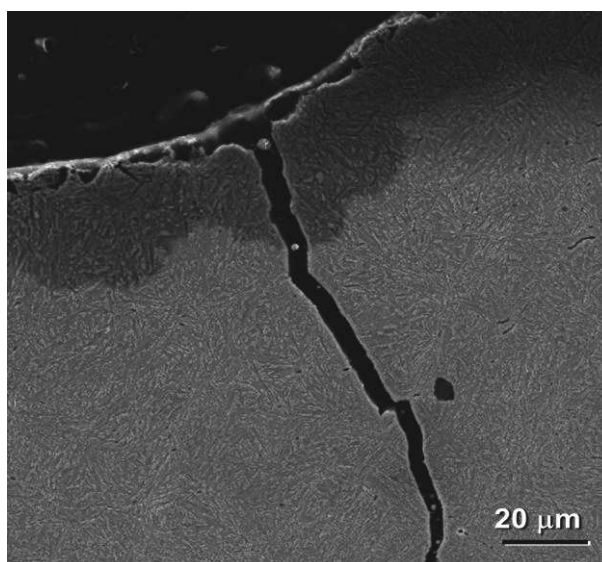
Fig. 11 Crack in the bottom of a tooth – scanning electron micrograph

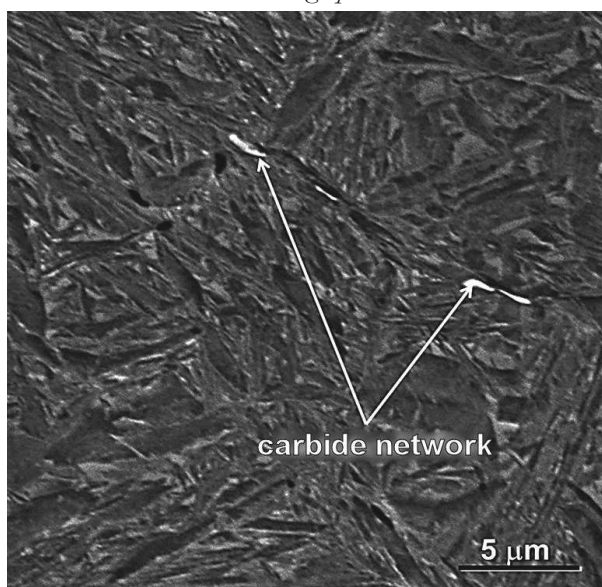
Fig. 12 Microstructure in the top of a tooth, carburized region with carbide network – scanning electron micrograph

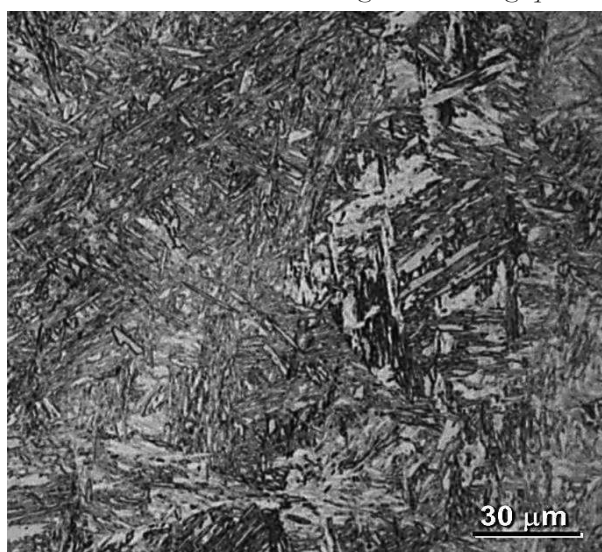
Under a light microscope, uniform mostly bainitic microstructure with a small amount of bainitic was identified (Fig. 13). This was confirmed by observation in a scanning electron microscope (Fig. 14) and

Fig. 13 Bainitic-martensitic microstructure, light micrograph

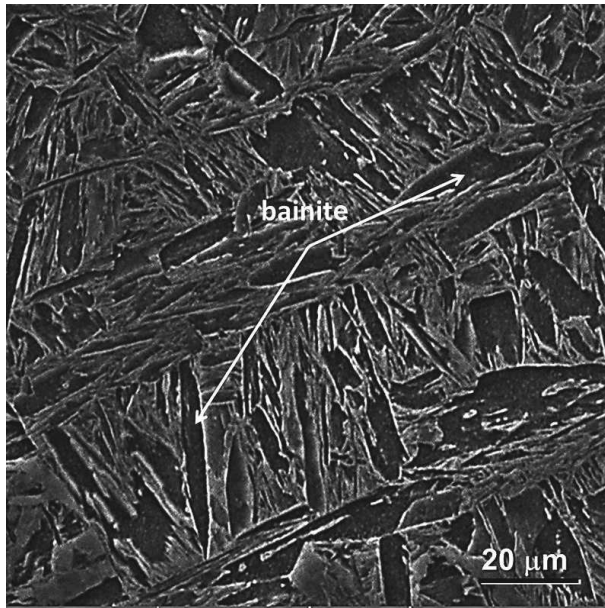
Fig. 14 Bainitic-martensitic microstructure, scanning electron micrograph

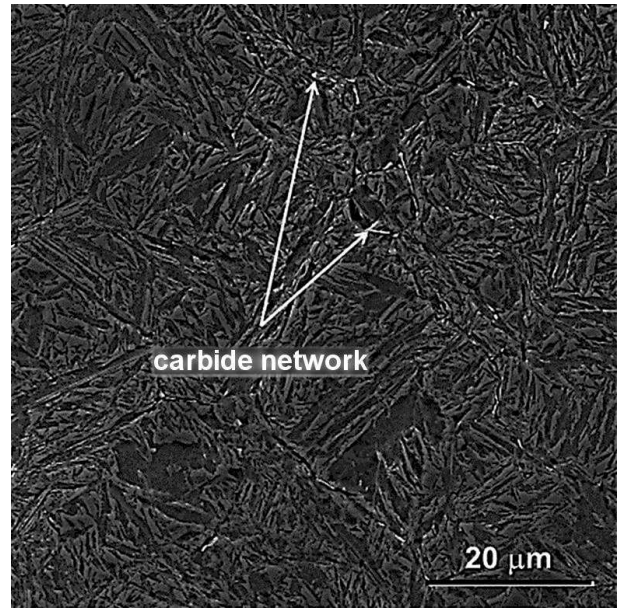
The metallographic section through a fracture surface of the wheel which failed in service showed cracks and carbide network along prior austenite grain boundaries. The latter was probably formed due to improper carburizing and super-saturation of the surface with carbon (Fig. 15). The carbon content should be around the eutectoid concentration (Fig. 1).

Fig. 15 Microstructure below the fracture surface in a tooth; carbide network is present

Failed gear wheels from off-road motorcycles made of ČSN 16720 chromium-nickel steel with a carburized layer of 0.8 mm were examined using metallographic techniques. It was found that the likely cause of the failure was improper carburizing conditions. Carbide network developed in the microstructure as a consequence of super-saturation of the surface layer with carbon. Carbon concentration exceeded the solubility of carbon in austenite which is indicated by the

A_{cm} curve in Fe-Fe₃C equilibrium diagram. As a consequence, cementite formed along grain boundaries in the course of carburizing. This cementite remained present after quenching, causing brittleness and, most likely, the failure. It is possible that stresses caused by quenching led to defects immediately.

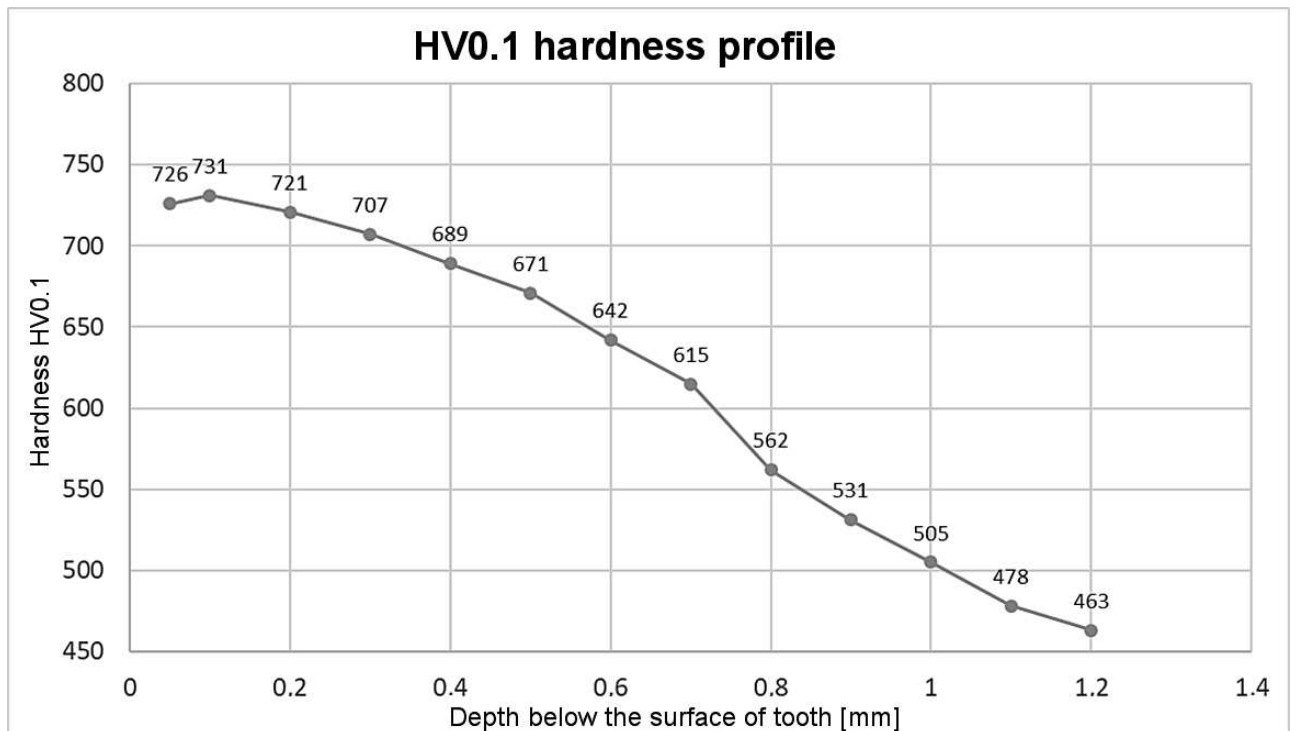
Hardness profile across the tooth was measured using a microhardness tester. Fig. 16 shows the depth profile of microhardness HV0.1 from the tooth face. This hardness profile suggests that the carburized layer depth is in line with the manufacturer specifications, i.e. approx. 0.8 mm.

Fig. 16 Hardness profile in the tooth
