Investigation into Damaged Gear of Off-Road Motorcycles

Dagmar Bublíková, Hana Jirková, Kateřina Rubešová, Zbyněk Bunda

University of West Bohemia, RTI-Regional Technological Institute, Univerzitní 22, CZ – 306 14 Pilsen, Czech Republic, e-mail: dagmar.bublikova@seznam.cz

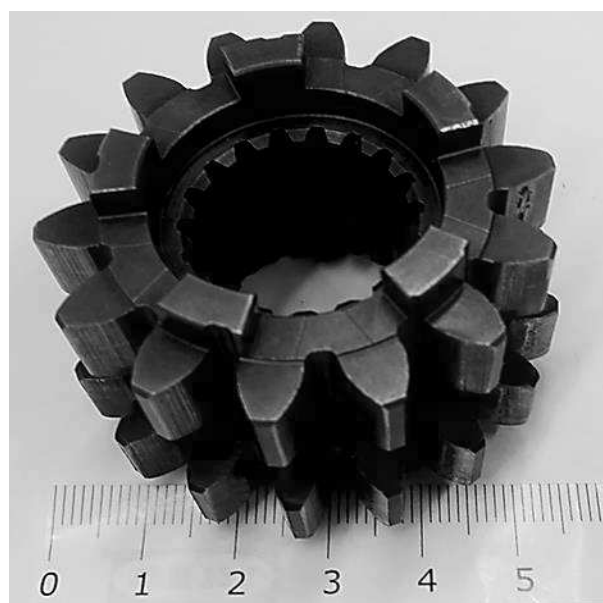
The gear wheels supplied for examination were made of chromium-nickel Czech Standard (ČSN) 16720 steel. They had two different diameters and were part of a gearbox of an off-road motorcycle (Fig. 2). The smaller addendum circle had a diameter of 50 mm and the related tooth height was 6.4 mm. The larger addendum circle was 53 mm in diameter and the tooth height was 5.9 mm. Chemical composition of the steel is given in Table 1. The gear teeth were carburized to a depth of 0.8 mm and hardened to 60-62 HRC. For the wheels the client required a life of 100 hours. The goal of the investigation was to identify the cause of the in-service failure in the wheels.

Fig. 2 Gear wheel from an off-road motorcycle
